# **FLOOD PLAIN MANAGEMENT**

**A Study Of South Fork  
Shenandoah Tributaries**

**Rockingham County, Virginia**

**QUAIL RUN – BOONE RUN**

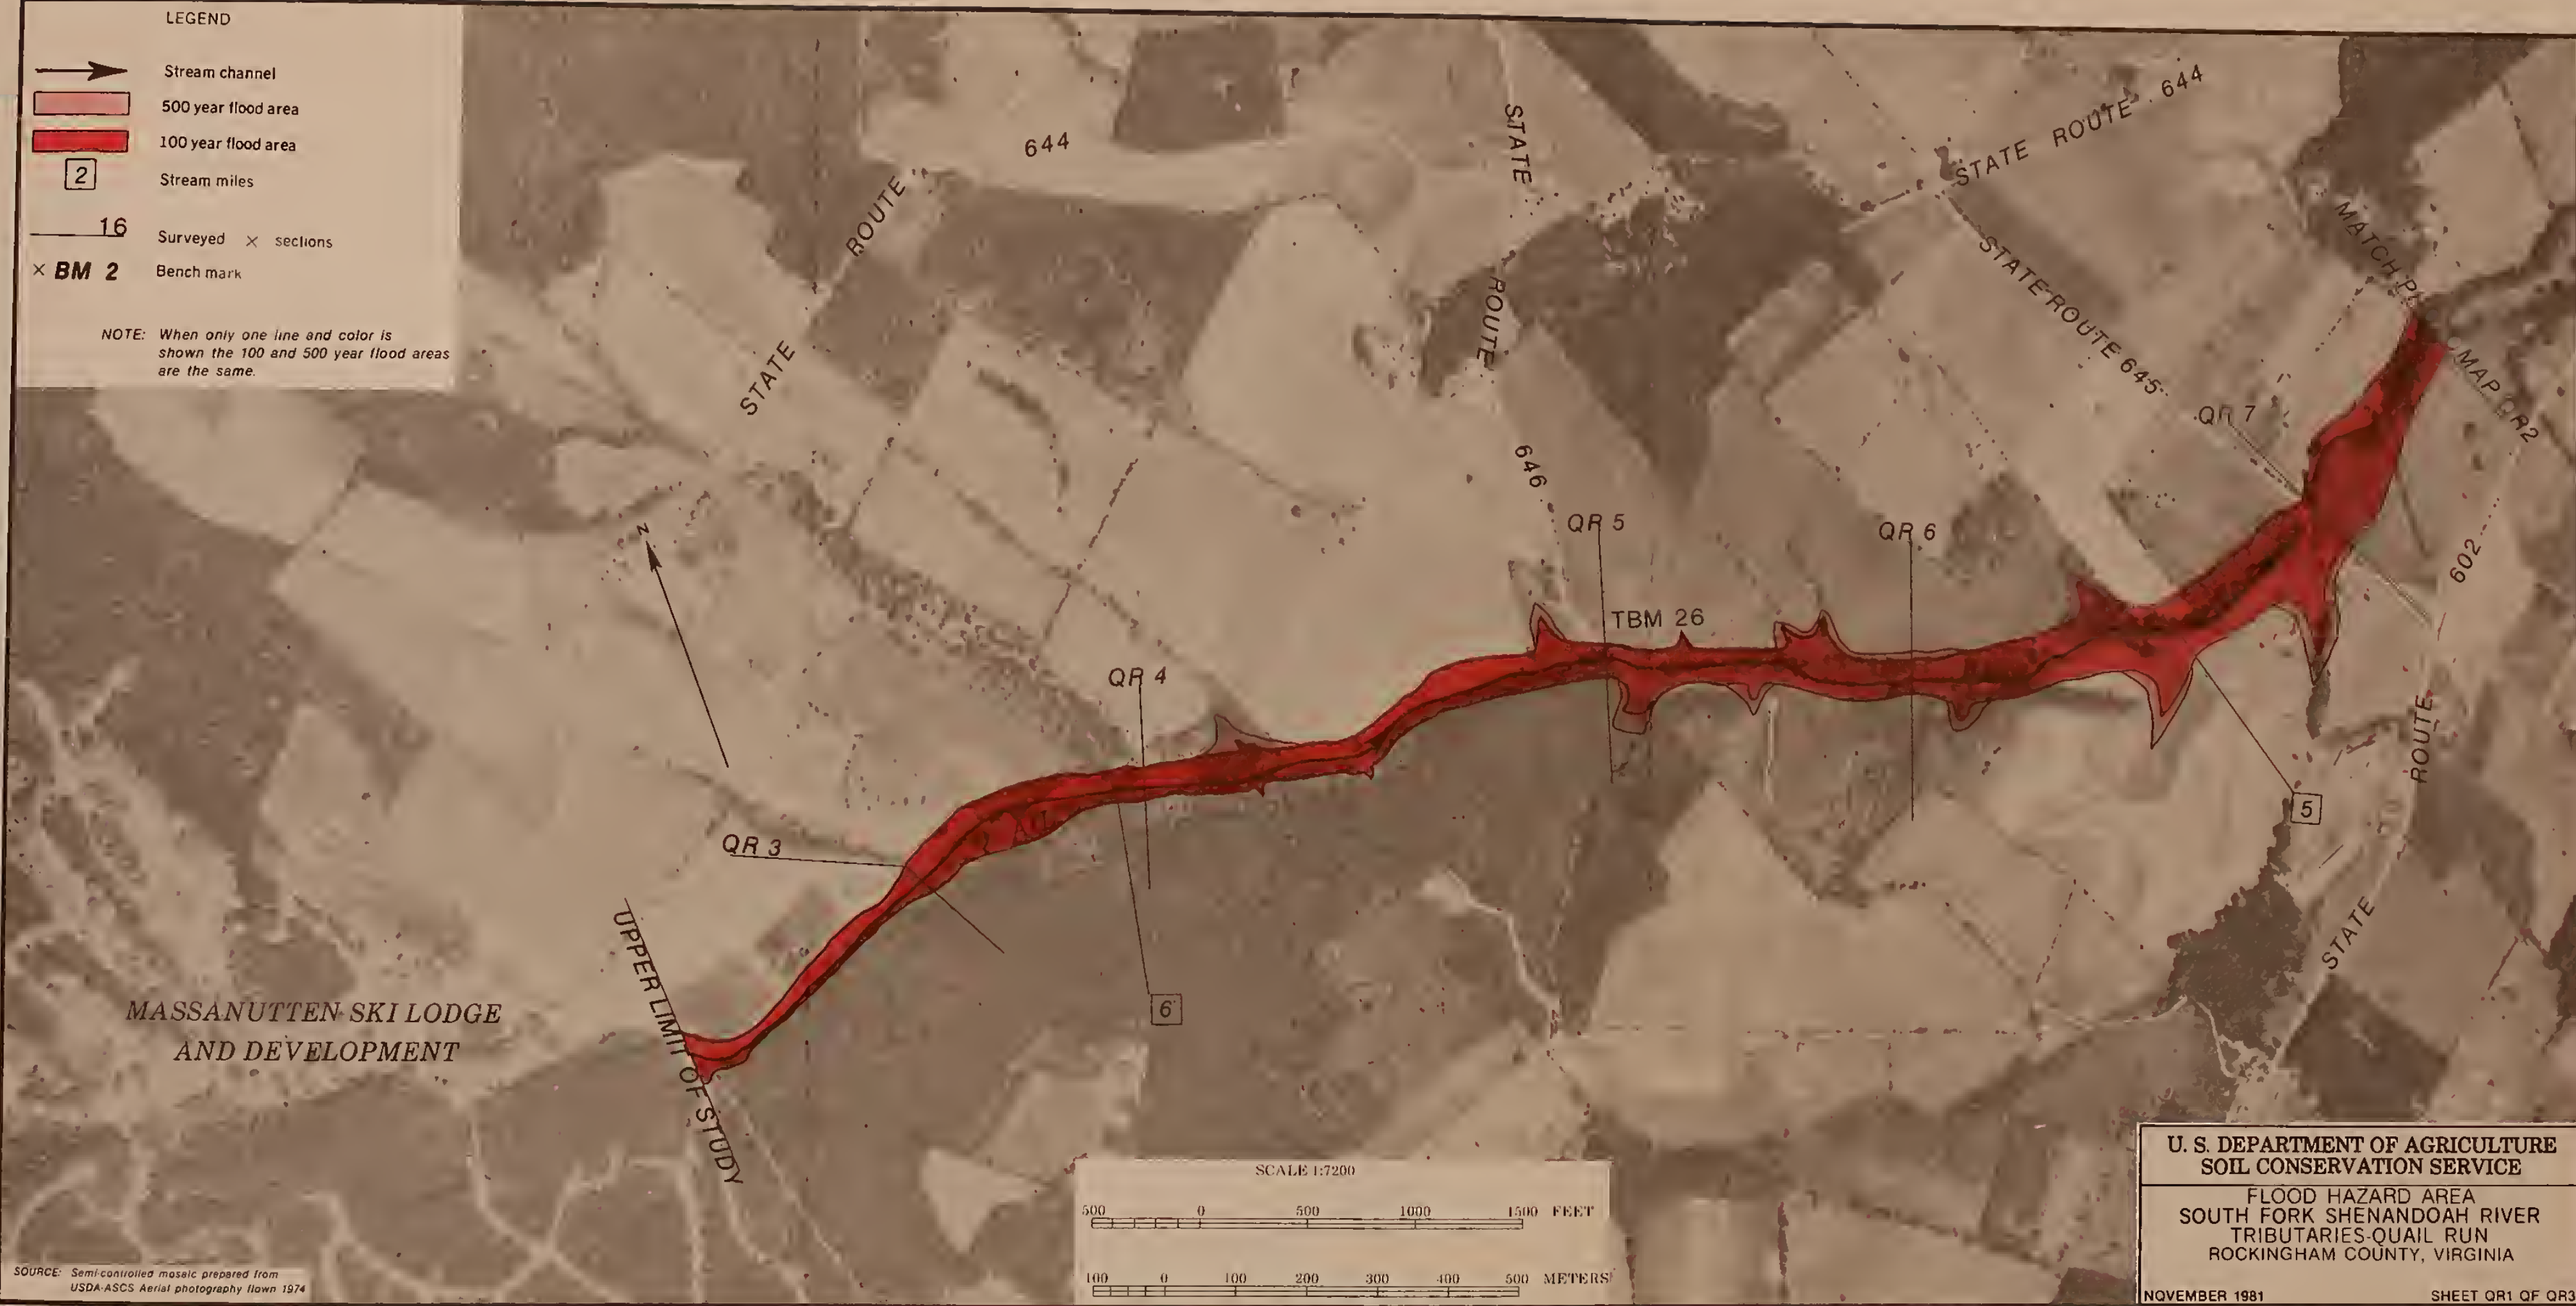
SHEET QR1 OF QR3

NOTE: When only one line and color is shown the 100 and 500 year flood areas are the same.

FLOOD HAZARD AREA  
SOUTH FORK SHENANDOAH RIVER  
TRIBUTARIES-QUAIL RUN  
ROCKINGHAM COUNTY, VIRGINIA

The index map shows the area covered by the individual photomaps. Flood hazard photomaps show the area inundated by the 100 and 500-year floods. Where only one line is shown, there is no significant difference in the boundaries of the two flood areas. These photomaps should only be used to determine approximate flood elevations; they are based on semicontrolled mosaics and the boundaries shown may vary from the location on the ground.

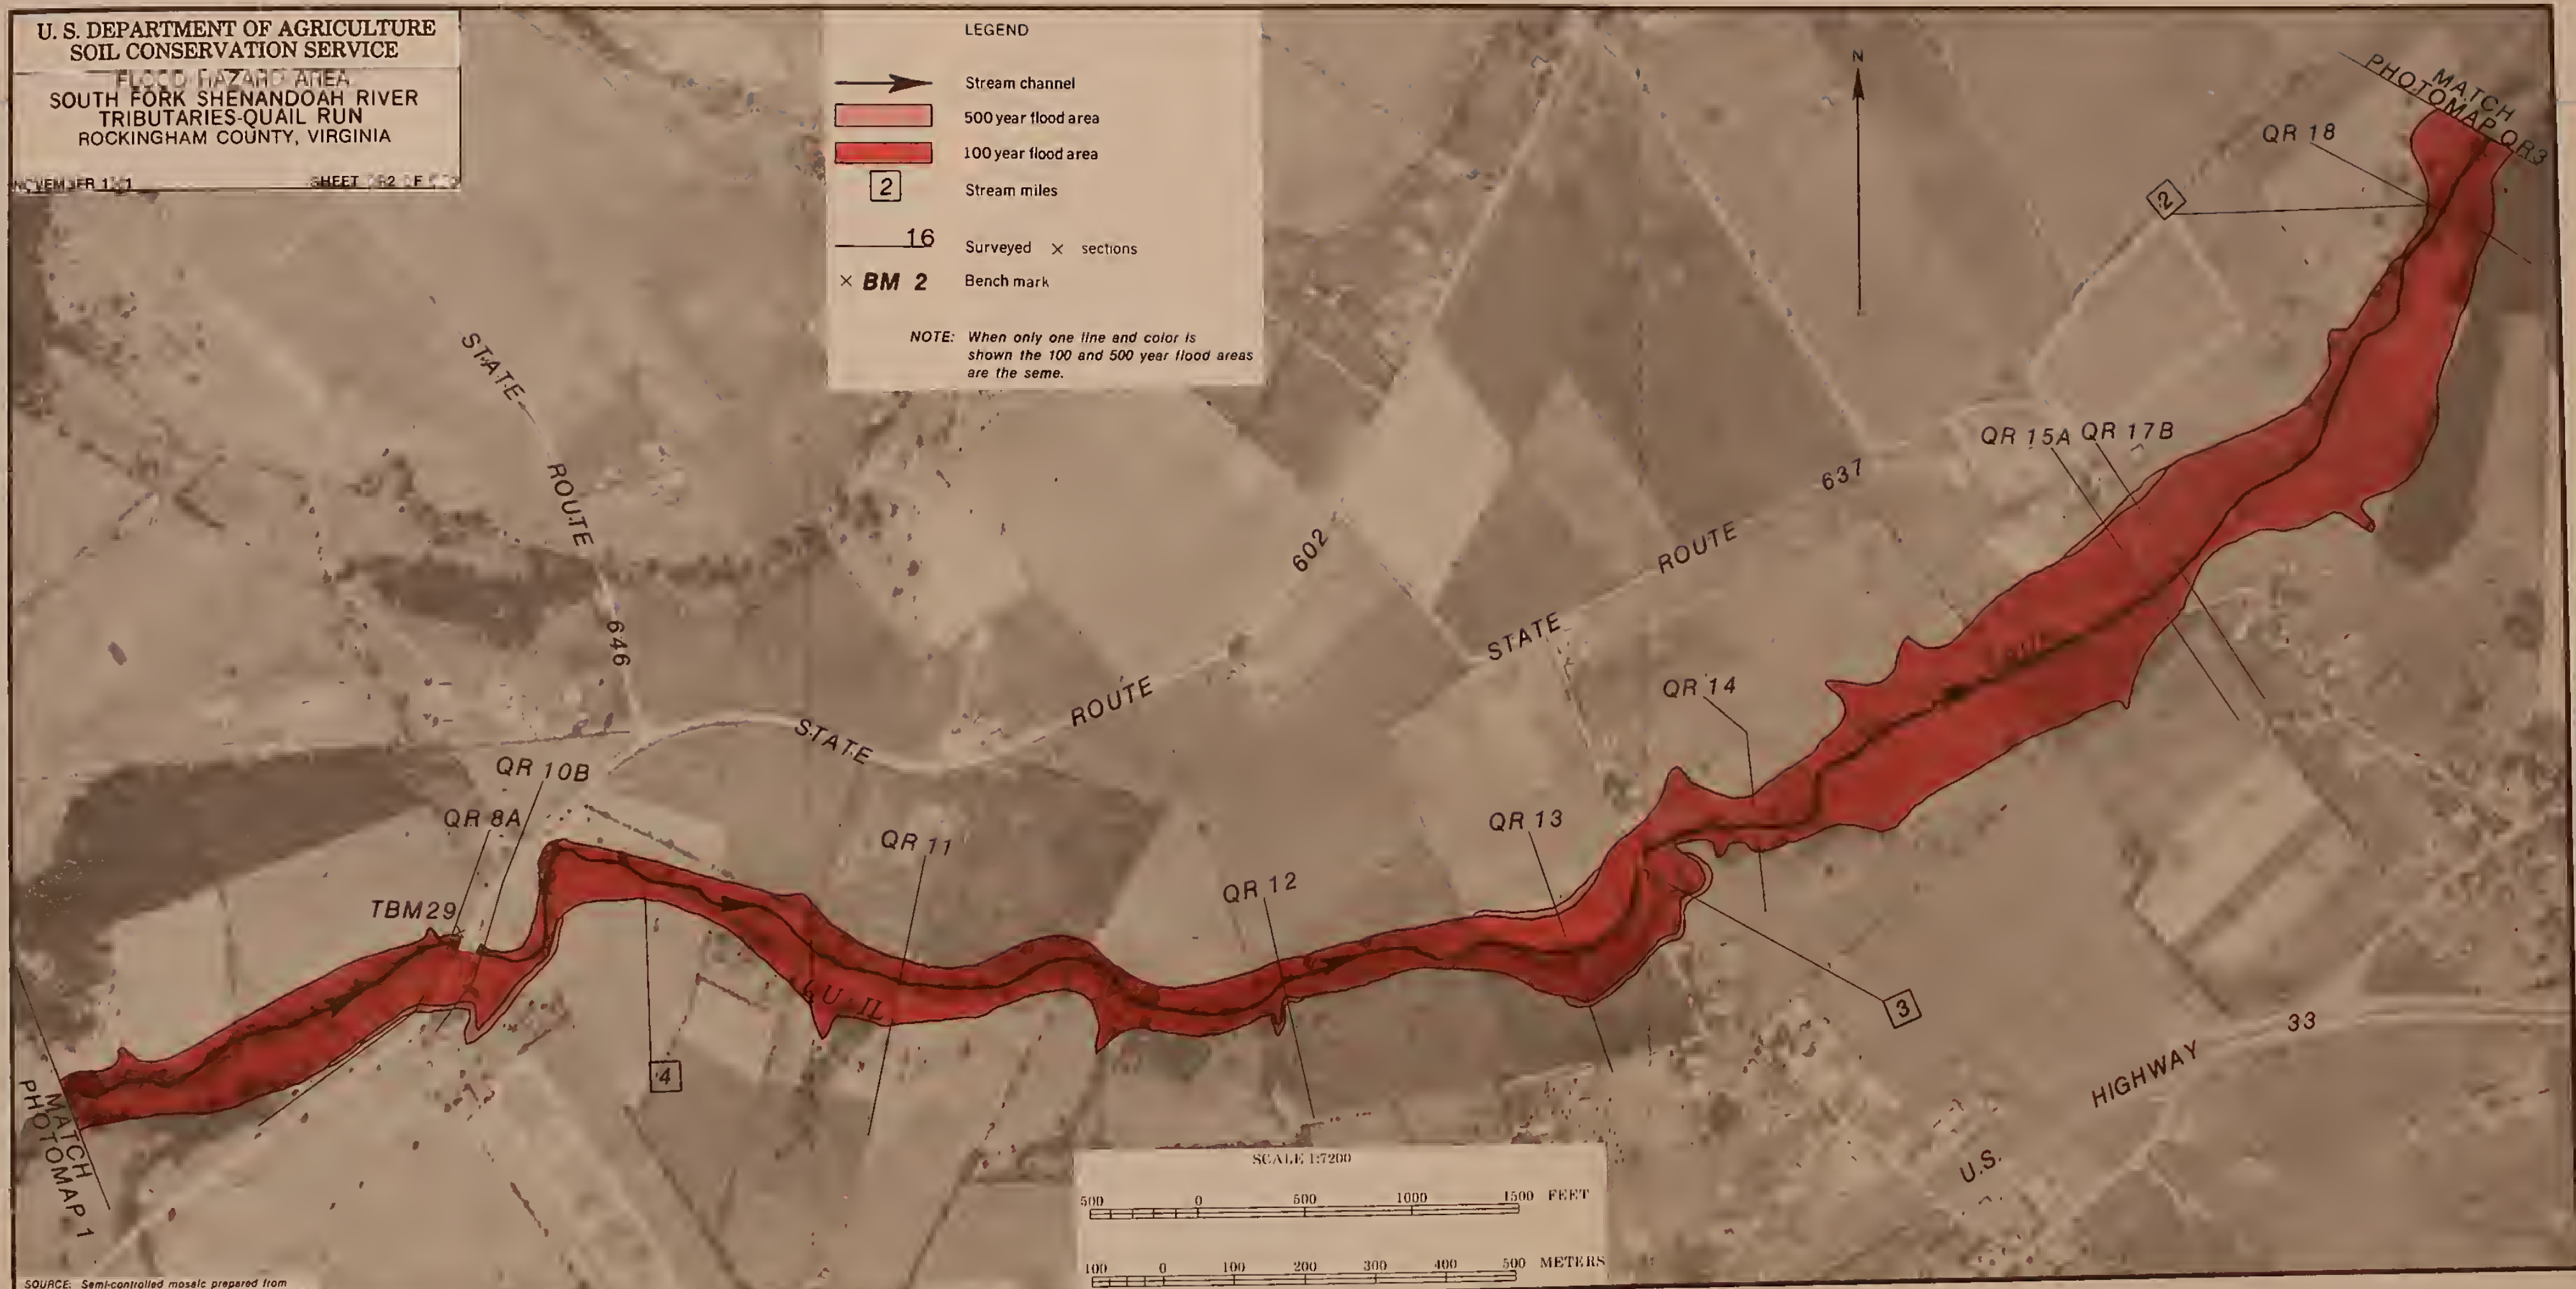
SOURCE: Semi-controlled mosaic prepared from  
USDA-ASCS Aerial photography flown 1974

Extreme floods would inundate about 440 acres of primarily agricultural land. Velocities would average about 3.5 feet per second and exceed six feet per second in some reaches. Out-of-bank stages would range from about 1.5 to 8.5 feet. Varying amounts of damage would occur to the five bridges and one structure present in the flood plain. Extensive damage would be done to the land with approximately 404 acres inundated by the 100 year flood, and 440 acres by the 500 year flood.

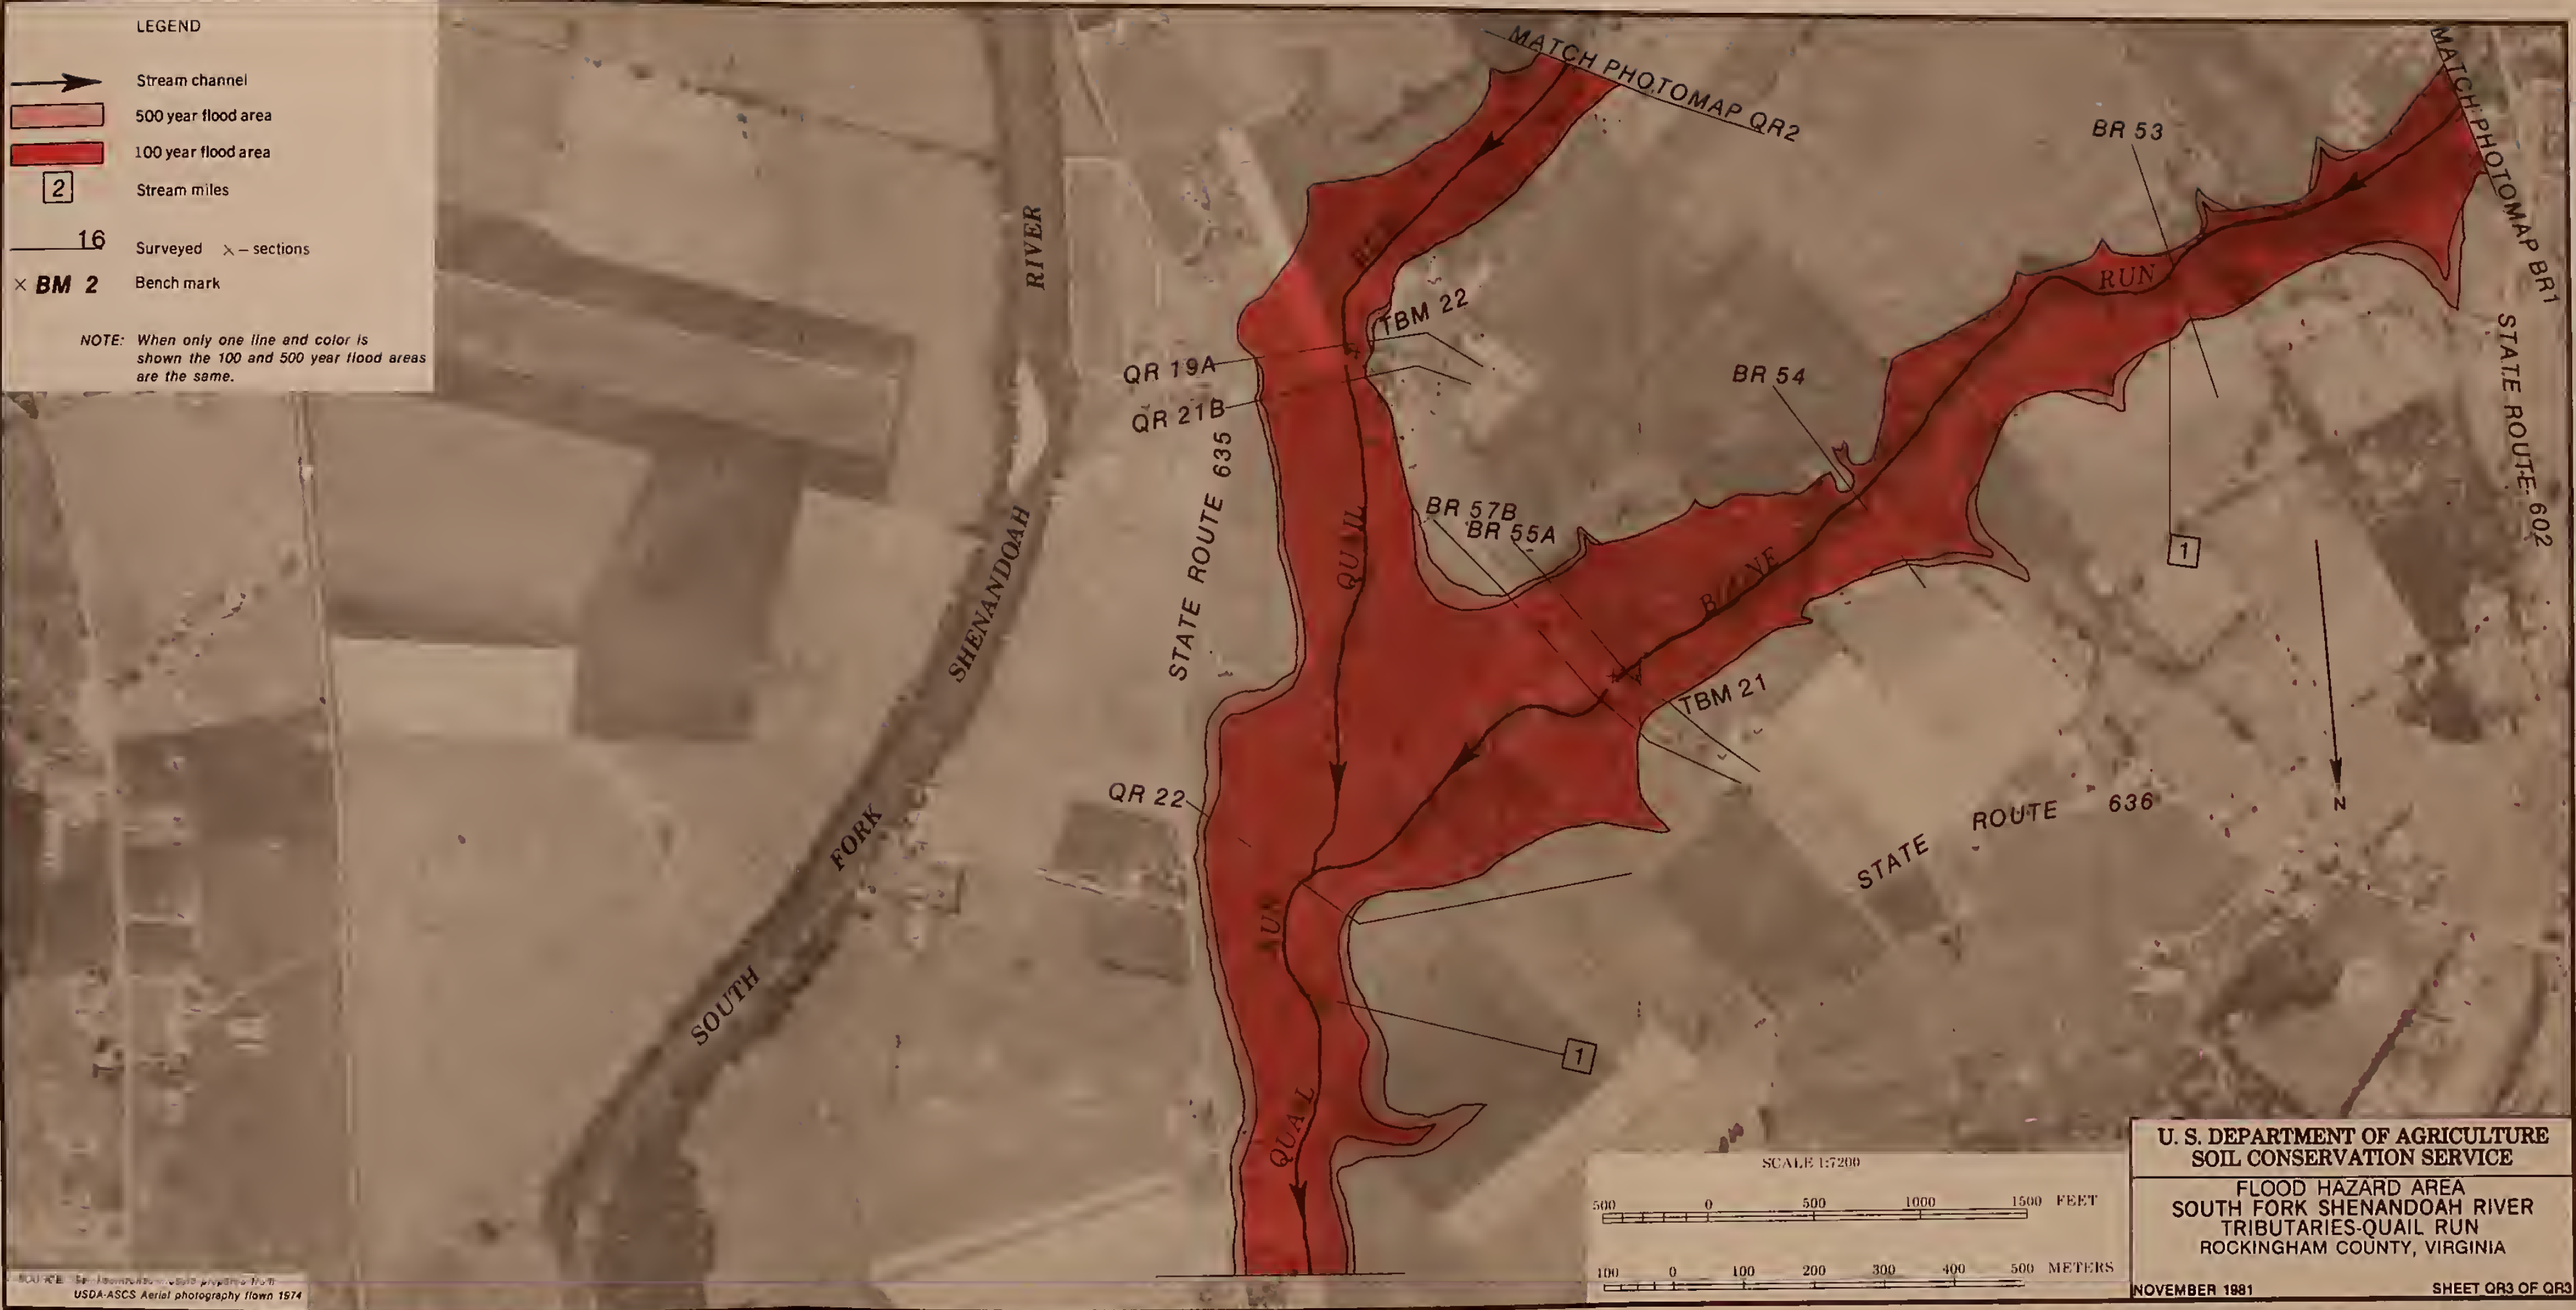
SHEET QR3 OF QR3

**NOTE:** When only one line and color is shown the 100 and 500 year flood areas are the same.

**FLOOD HAZARD AREA  
SOUTH FORK SHENANDOAH RIVER  
TRIBUTARIES-QUAIL RUN  
ROCKINGHAM COUNTY, VIRGINIA**

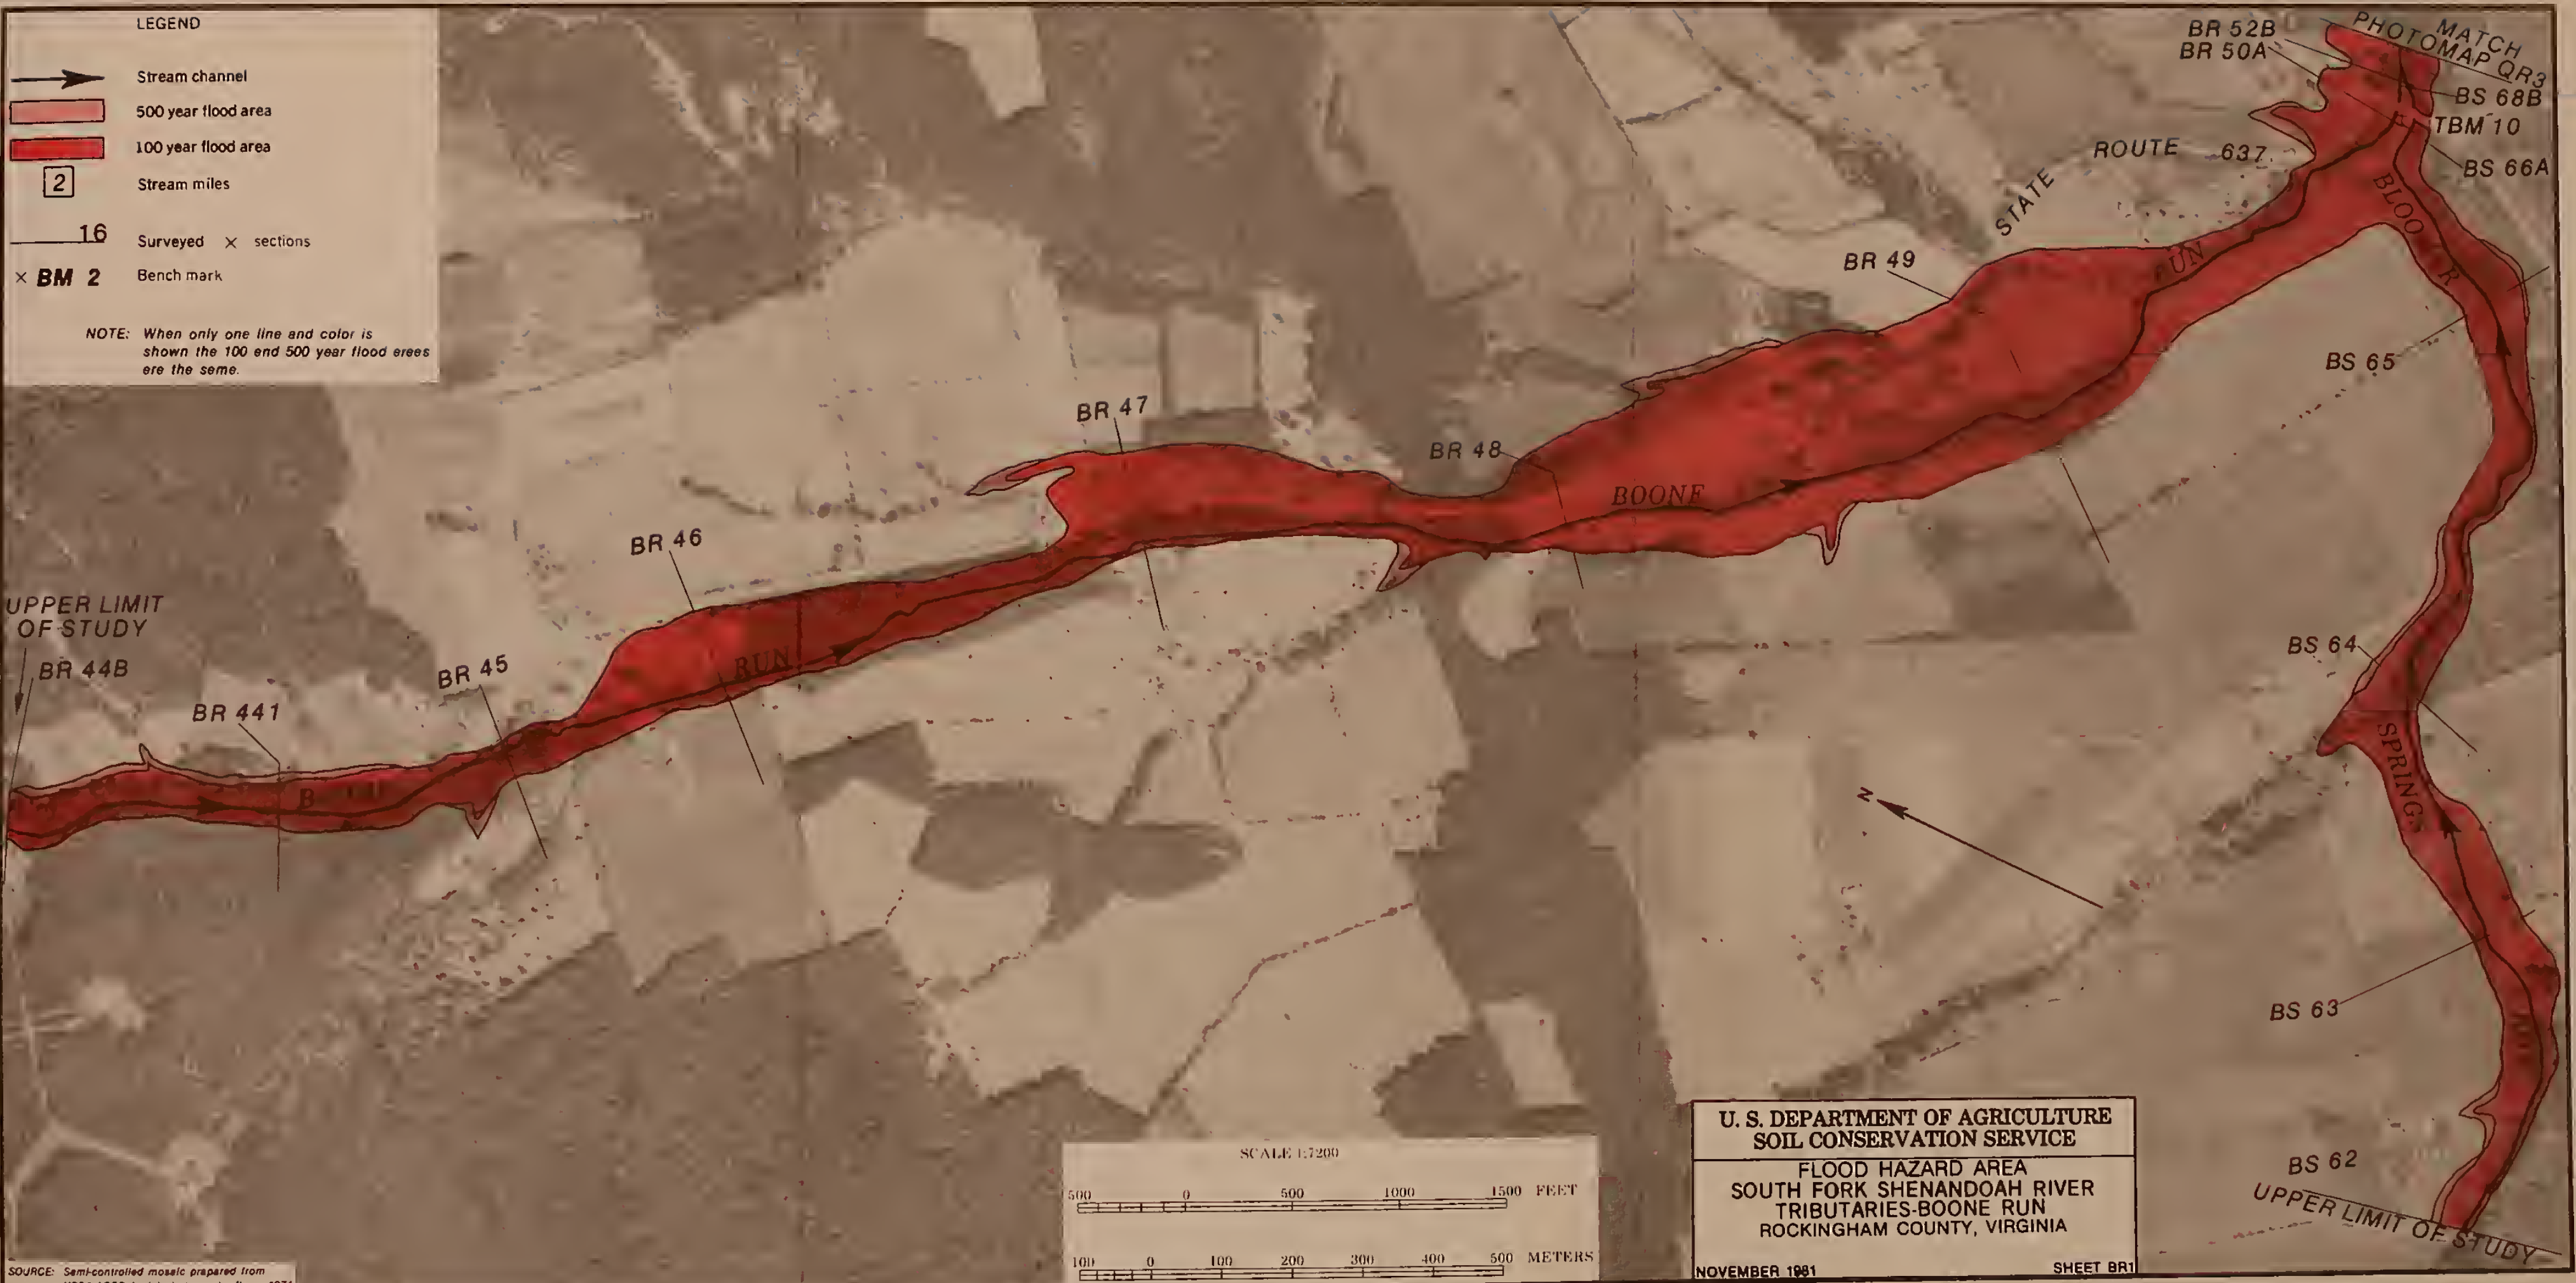
SHEET BR1

**NOTE:** When only one line and color is shown the 100 and 500 year flood areas are the same.

**FLOOD HAZARD AREA  
SOUTH FORK SHENANDOAH RIVER  
TRIBUTARIES-BOONE RUN  
ROCKINGHAM COUNTY, VIRGINIA**

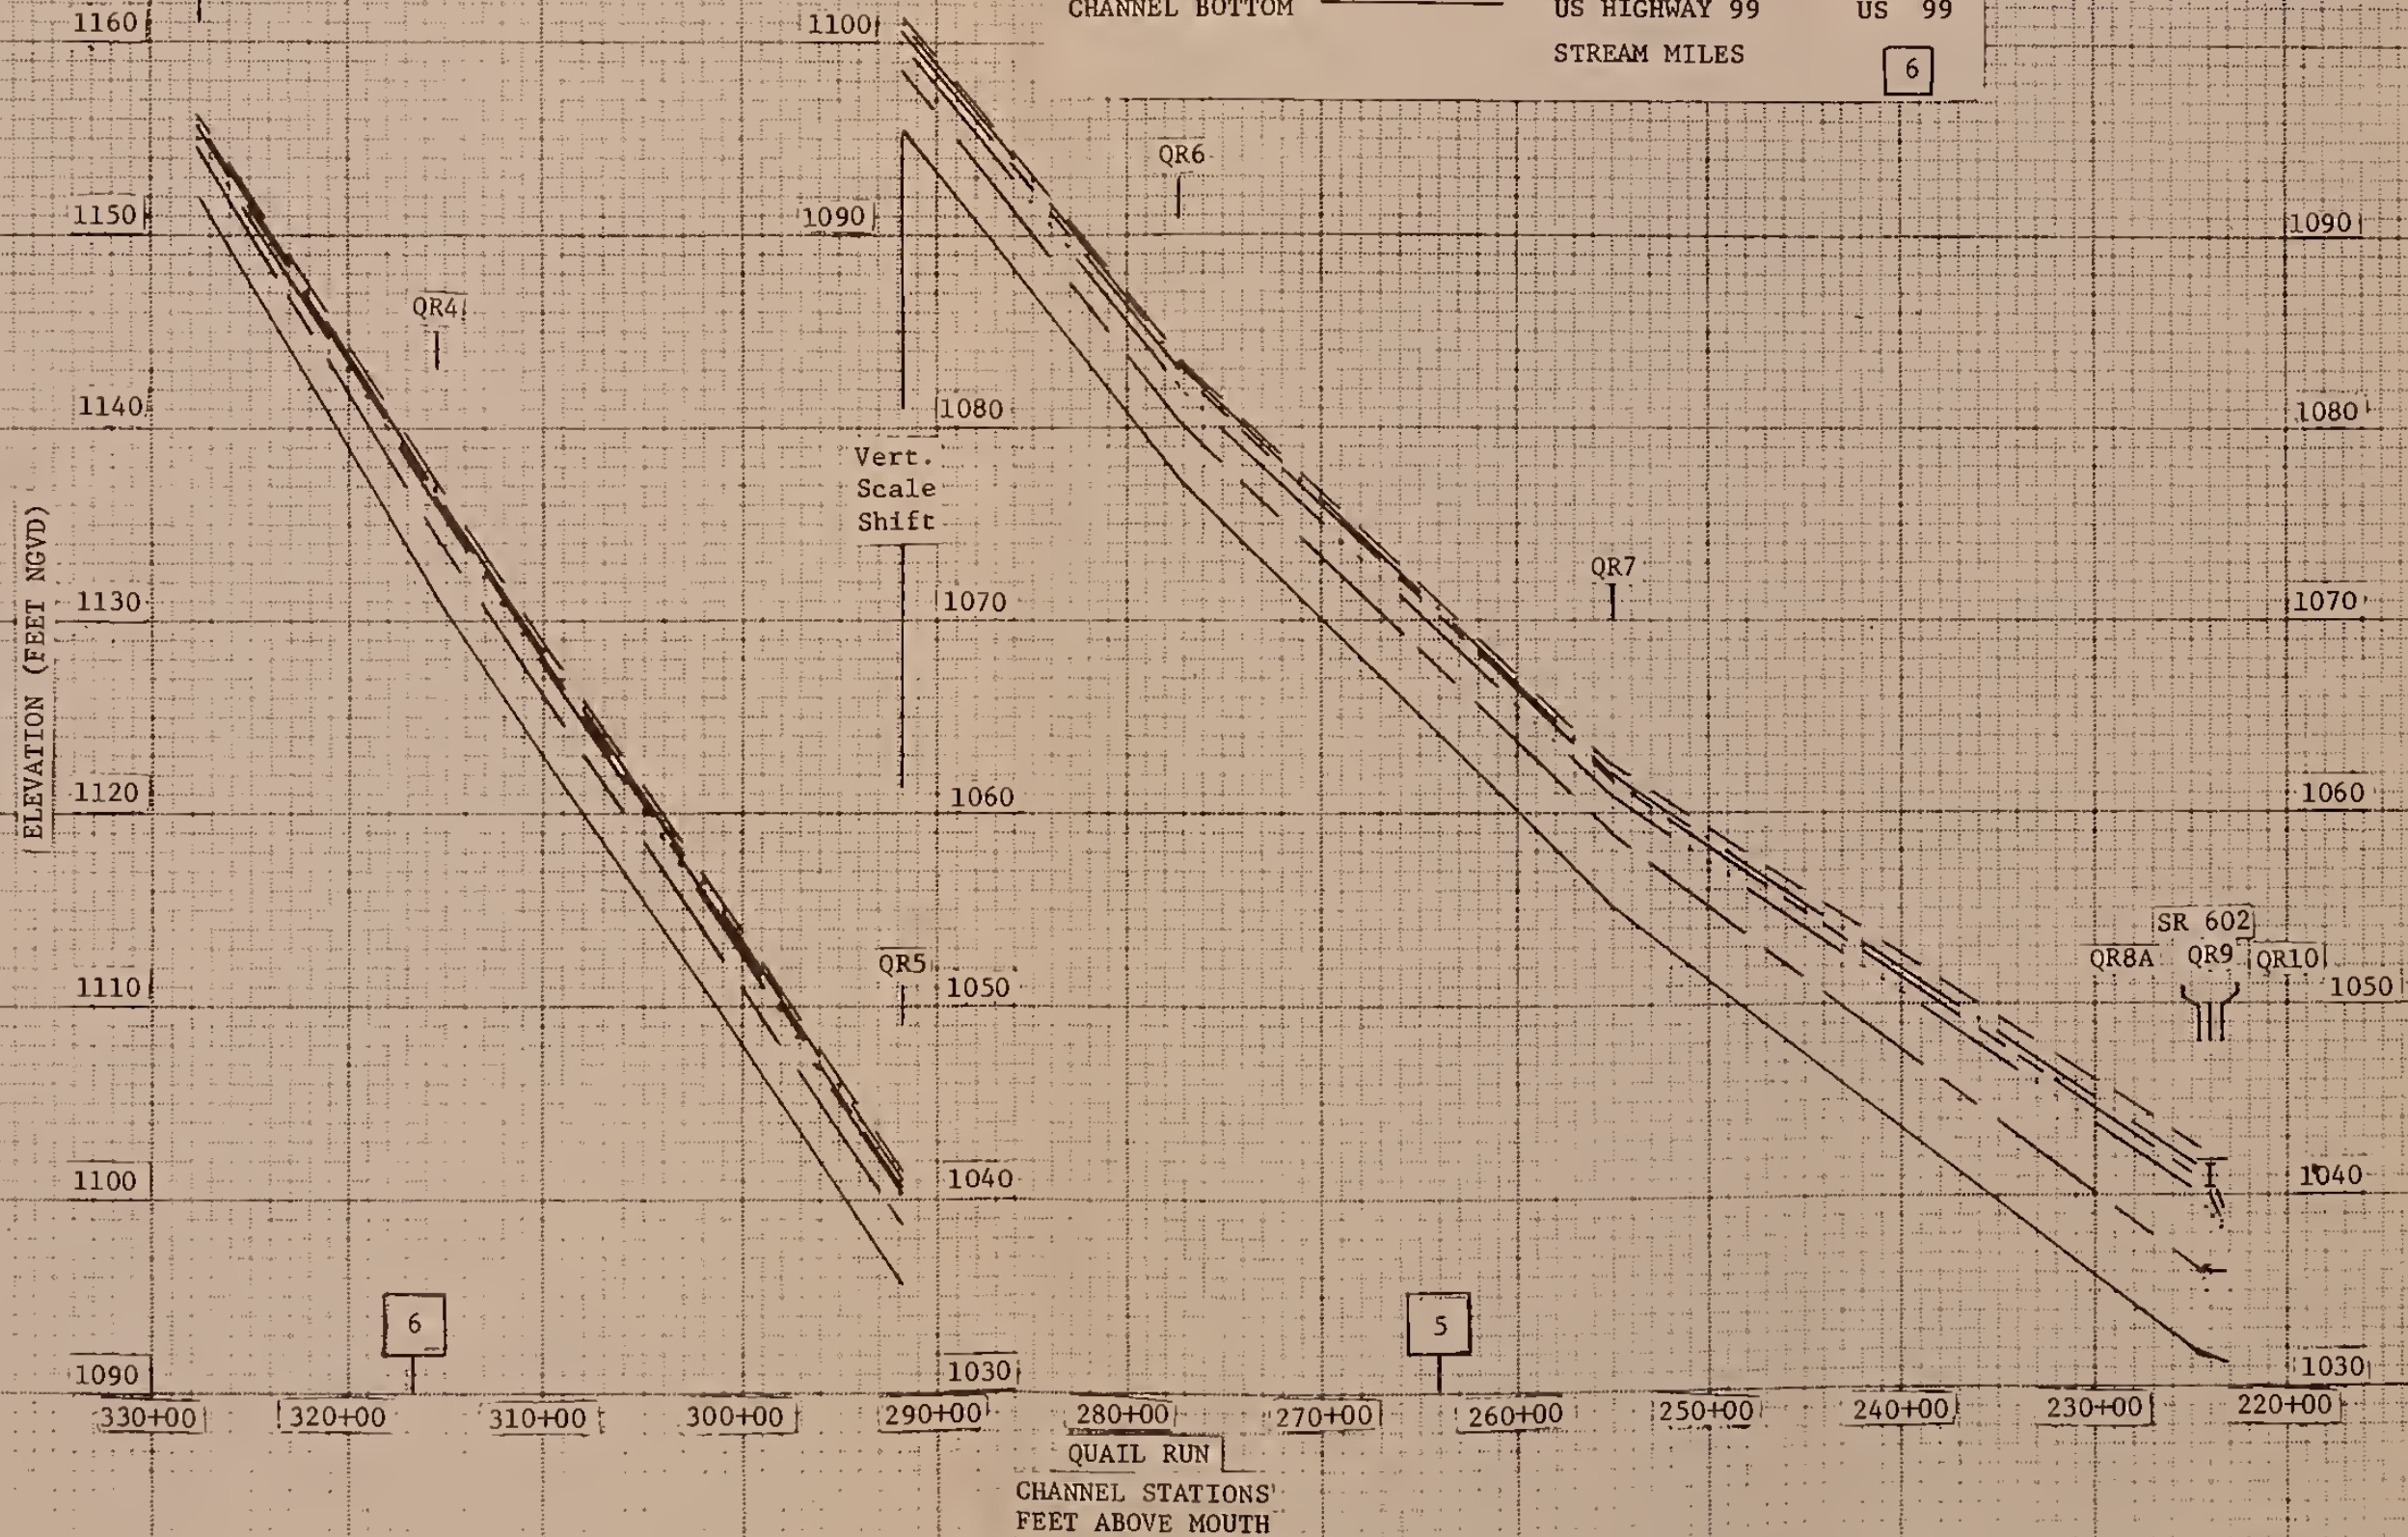
Designated \_\_\_\_\_ Date \_\_\_\_\_  
Project MAM 10/79  
Traced \_\_\_\_\_  
Checked \_\_\_\_\_  
PLATE 1 of 8  
QUAIL RUN - See  
Photomap QR1

## FLOOD PROFILES

S FK SHENANDOAH RIVER TRIBS  
ROCKINGHAM COUNTY, VIRGINIA  
U. S. DEPARTMENT OF AGRICULTURE  
SOIL CONSERVATION SERVICE

Flood profile plates provide elevations of the 10, 50, 100 and 500-year floods at any location along the length of the streams. The elevations and discharges of the 10, 25, 50, 100 and 500-year flood at each surveyed cross section are given in Table QR-1. Sample cross sections illustrated how the flood area boundaries were located. Table QR-2 provides the description and elevation of benchmarks which are located on the photomaps.

1. On the appropriate photomap find the point on the stream where the flood line is to be located; then scale the distance along the stream to the nearest cross section.
2. On the appropriate flood profile sheet, scale the distance determined in Step 1 from the cross section back to the original stream location, and read the elevation of the desired flood frequency line.
3. Transfer the elevation determined in Step 2 to the ground from the nearest established benchmark.

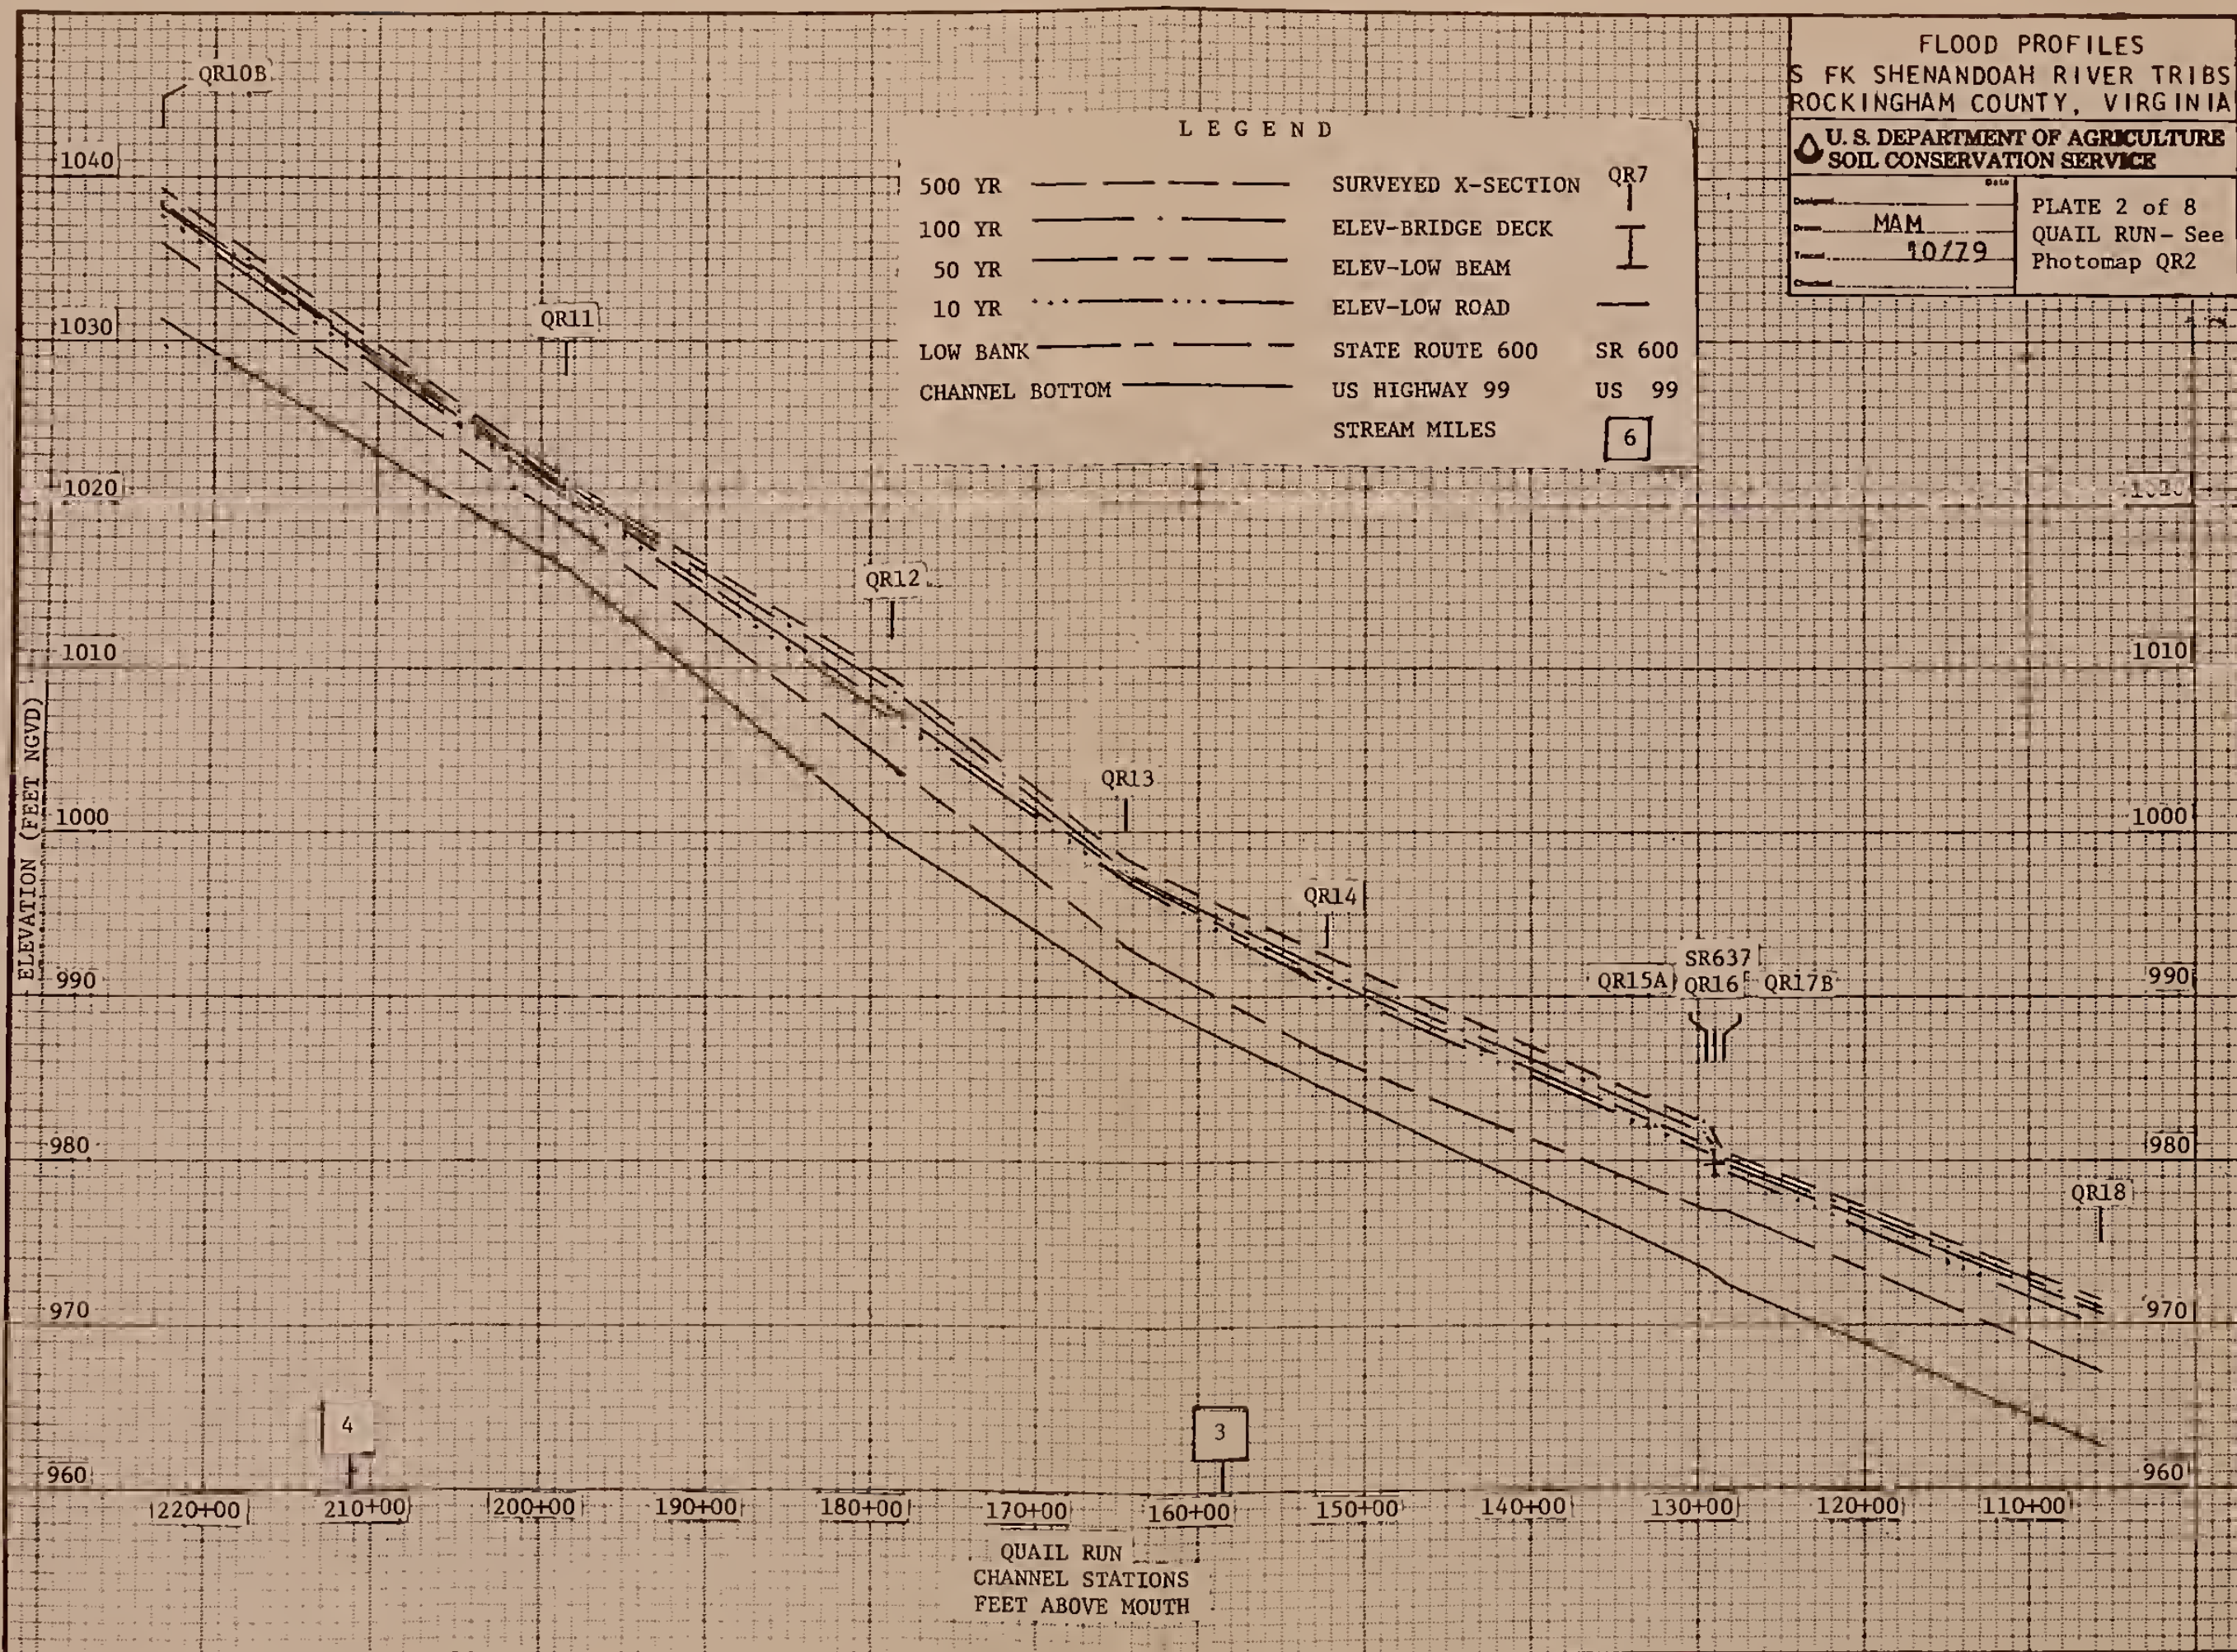
Design: MAM  
Drawn: 10/79  
Checked:   
Date:   
Plate: PLATE 2 of 8  
Quail Run - See Photomap QR2

FLOOD PROFILES  
S FK SHENANDOAH RIVER TRIBS  
ROCKINGHAM COUNTY, VIRGINIA
